Baseline Survey of Tamar Estuary Shoreline Banks

Report prepared for NRM North – May 2007

Matthew R. Sheehan & Joanna C. Ellison

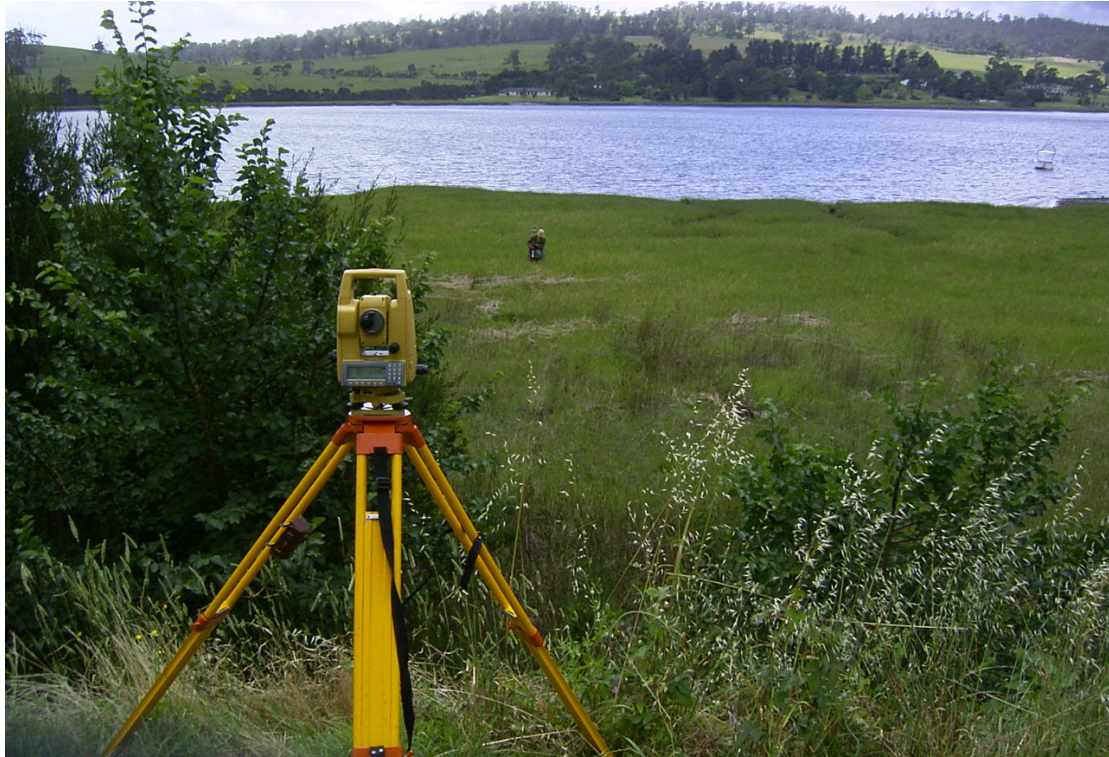
Figure 2.2: Surveying Marsh surface at Rosevears (W07).

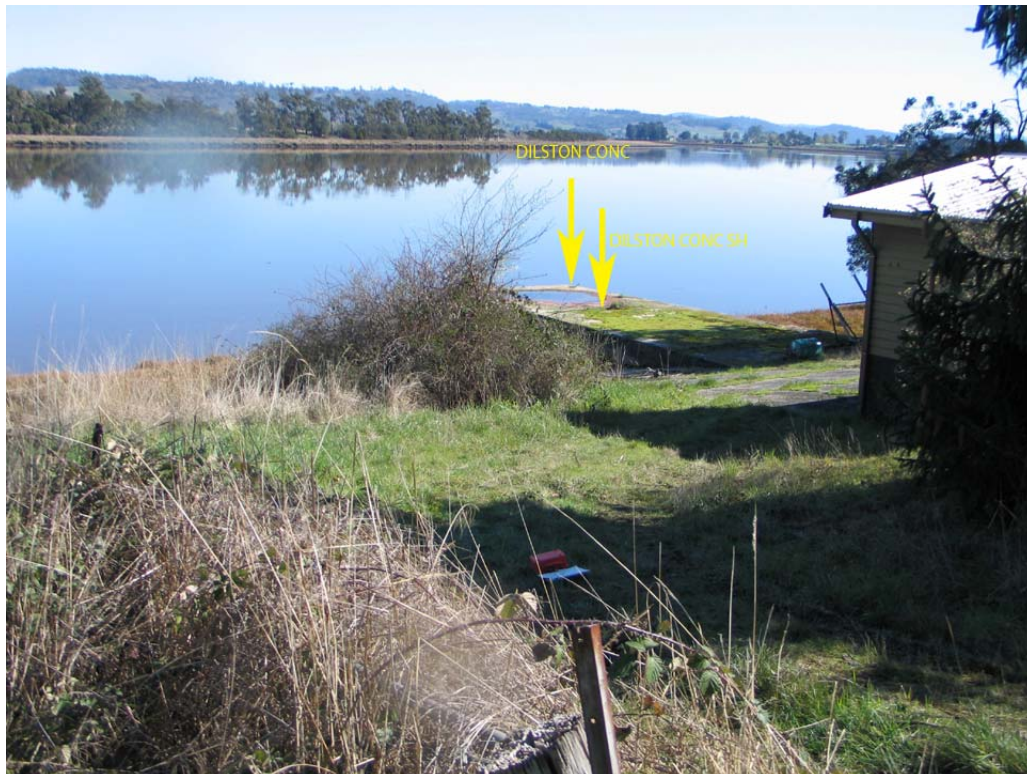
**Figure 3.2:** Photo taken from DILSTON POST looking toward other benchmarks.

1.6974	Aust Height Datum (Tas) 1983		Satellite - GPS		Third
Mark Details						
Description	Roofing nail in the centre of large concrete platform					
Locality	On concrete platform in the foreshore reserve in front of “Tarcoola”, 1291 East Tamar Hwy, Dilston					
Sight access	Walk in from “Tarcoola”. Land property access required.					
Backsight Information						
	Easting	Northing	Ht	Bearing	Dist	Description
DILSTON CONC	506455.0928	5423871.439	1.6457	260.4510	6.603	See Fig 3.2 & 3.3
DILSTON POST	506501.669	5423867.996	7.2175	96.3400	40.329	See Fig 3.4
Note	The transect is offset from the STN. Refer to bearings and distances on Figure 3.5 to determine the alignment.

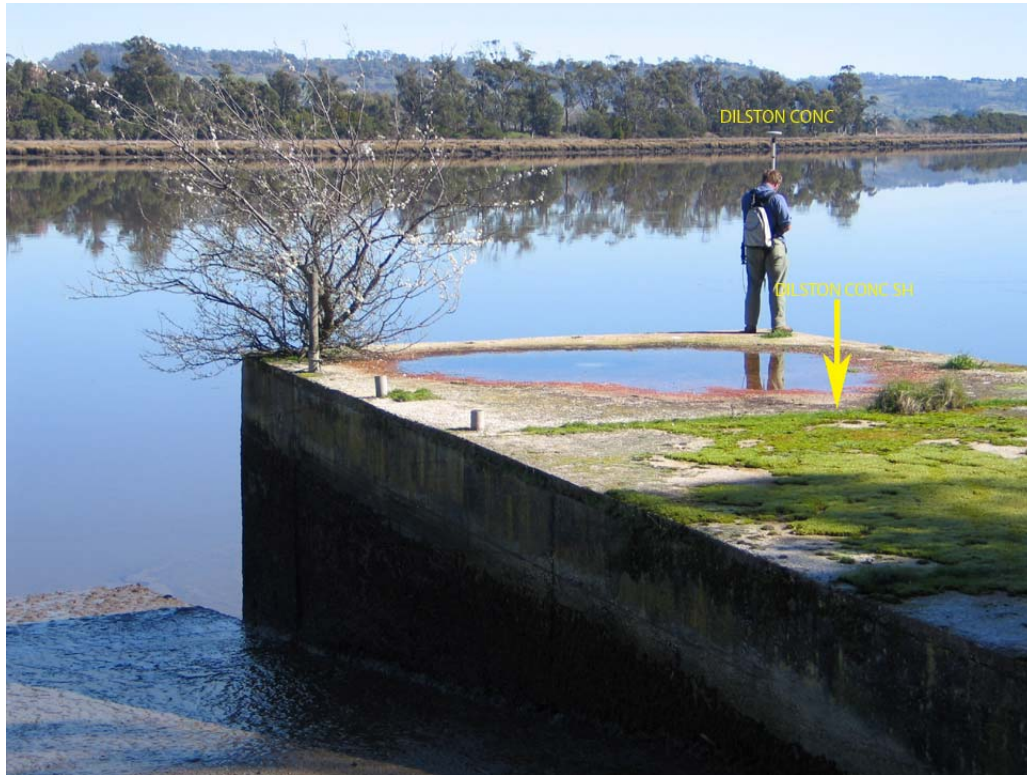
Figure 3.3: DILSTON CONC, the main backsight, is on the corner of the concrete slab. DILSTON CONC SH is located in the centre of the slab and is the Station for the transect. The Transect is to the right of the photograph.

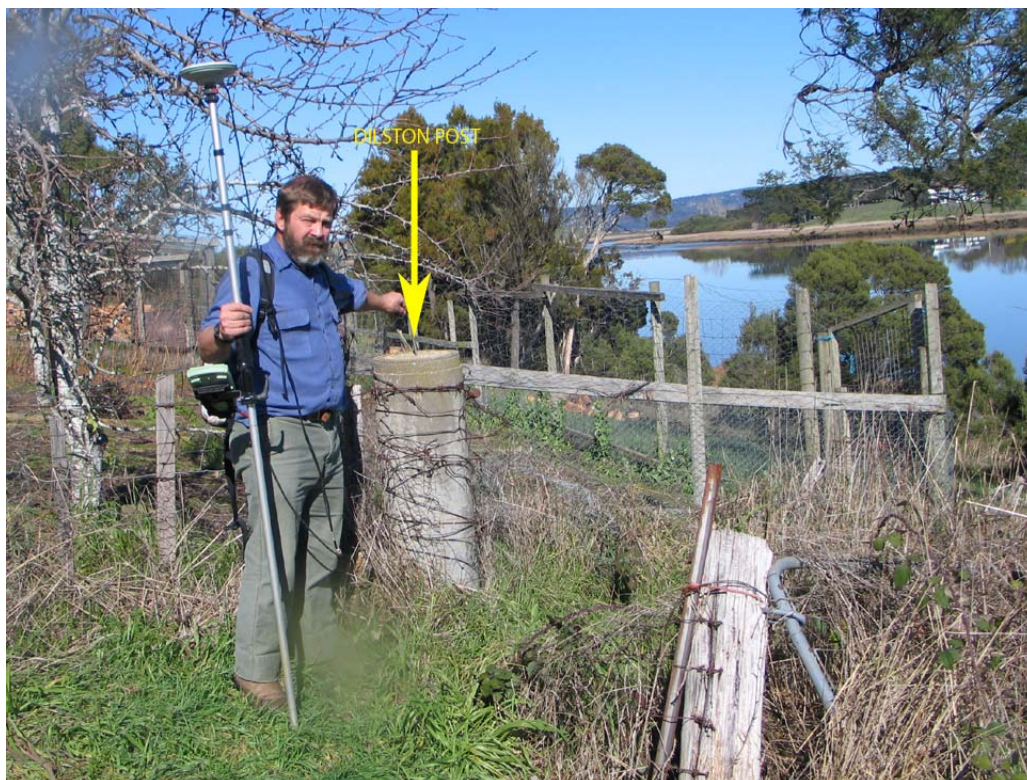
Figure 3.4: DILSTON POST was used as a secondary backsight and is in the centre of a large concrete boundary post

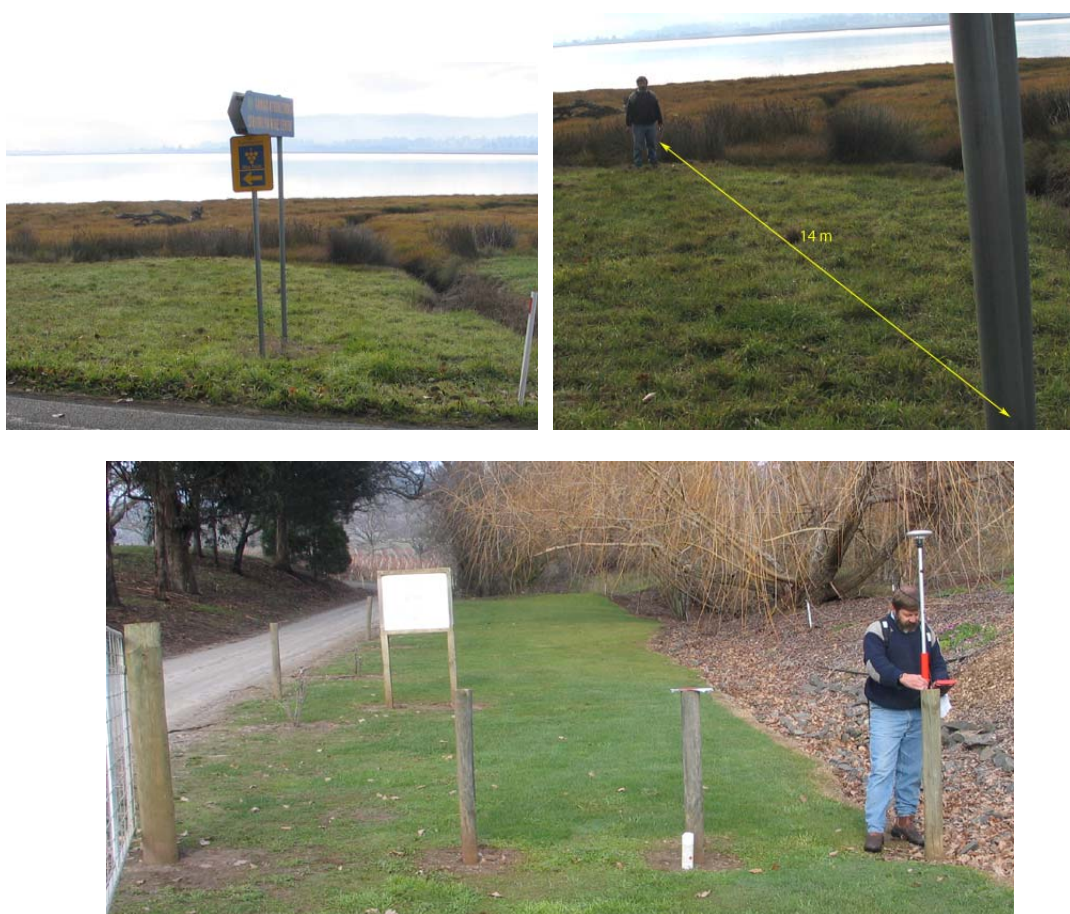
Figure 3.12: Transect W04, Rosevears, In front of Strathlyn Winery. **a)** and **b)** show location and distance to STN from sign, and **c)** shows Backsight.

W0405 (E04 – Rosevears 1)						
Horizontal Information						
	Zone	Easting		Northing		Transect bearing
	55	501776.3972		5423543.934		45.2100
	Datum			Survey Class		Order
	Geocentric Datum of Aust 1994			B		Second
Vertical Information						
	Ht	Datum		Survey Class		Order
	1.7955	Aust Height Datum (Tas) 1983		Satellite - GPS		Third
Mark Details						
Description	Round concrete plug in PVC pipe with brass screw marking point.					
Locality	Opposite Strathlyn Winery, 14 metres seaward from the ‘Tamar Attractions’ sign.					
Sight access	Two wheel drive vehicle access.					
Backsight Information						
	Easting	Northing	Ht	Bearing	Dist	Description
POST	501734.6861	5423496.764	6.202	221.2905	63.016	See Fig 3.12c.

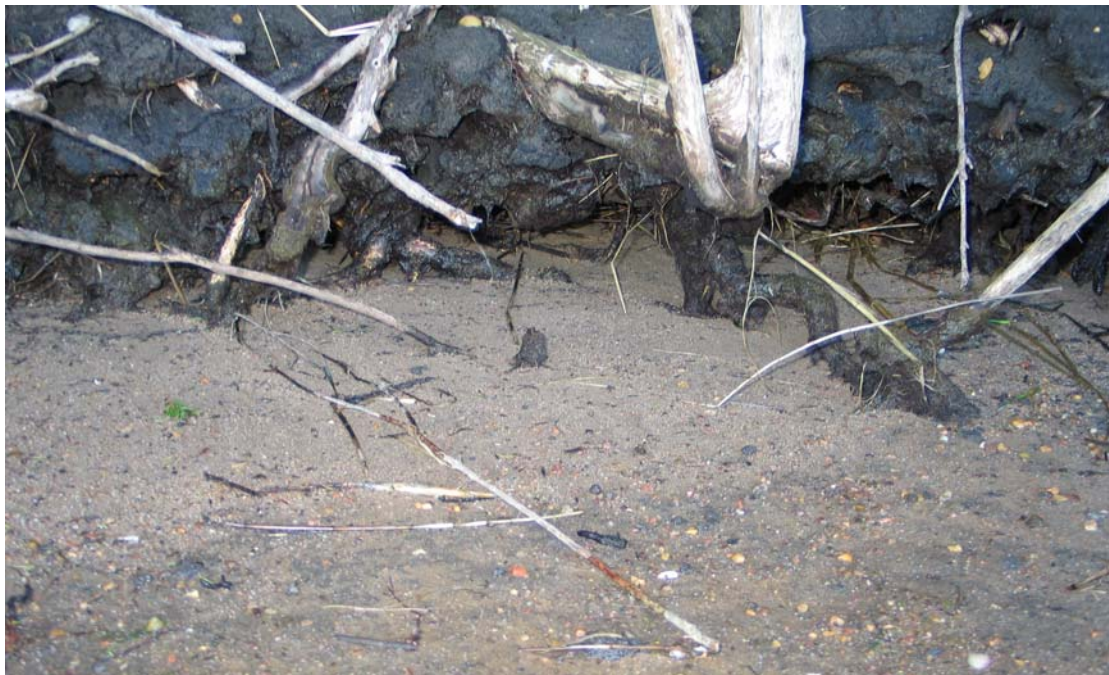
Figure 5.3: Sands and gravels are ‘sapped’ out of the high water bank by ground water and deposited as thin veneer upon the fine silts and clays of the *Spartina* Marsh near Little Swan Point. This process is likely to explain larger scale bank retreat observed between, Little Swan Point and Swan Point (figure 5.2.)

Erosion of HW banks both landward of *Spartina* marshes and where they are absent is of particular concern and likely to be exacerbated, if not caused by non-marine processes. Detailed geomorphological assessment of these Landforms and associated erosional processes is required to enable appropriate future management.
